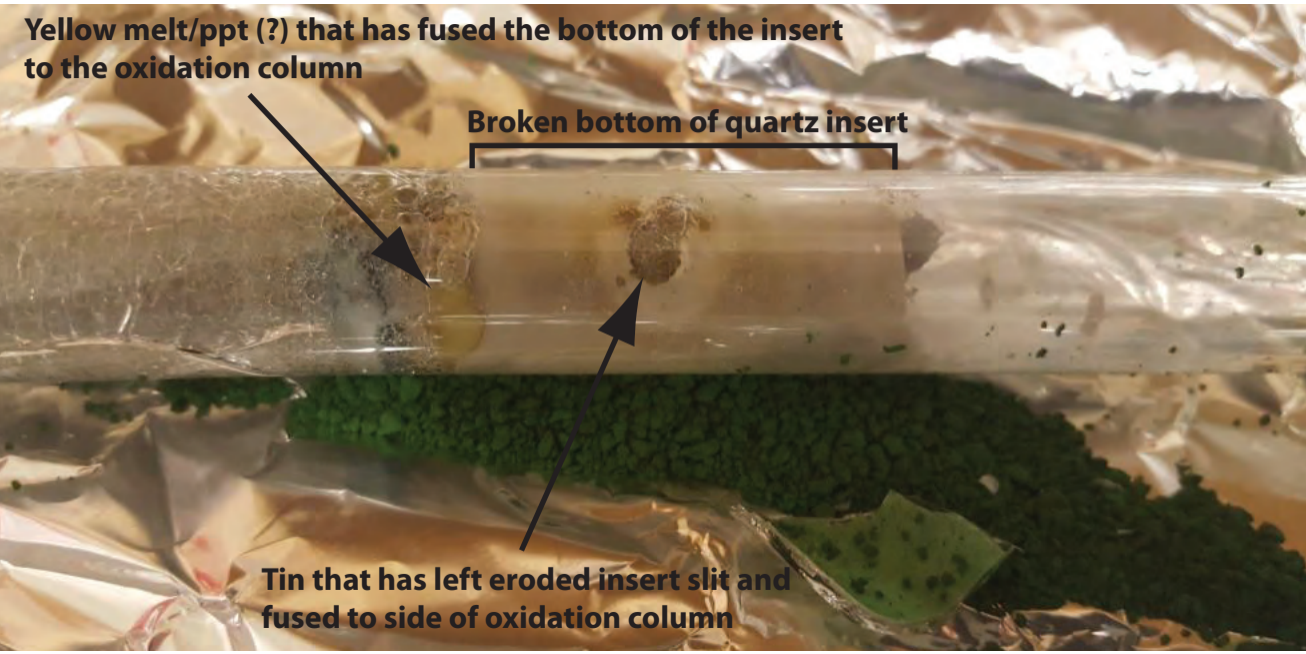
Yellow melt/ppt (?) that has fused the bottom of the insert to the oxidation column

Broken bottom of quartz insert

Tin that has left eroded insert slit and fused to side of oxidation column
